ieema journal

VOL 17 • ISSUE NO. 11 • JULY 2026

Prevention of Sudden Explosive Failures: Condition Assessment Techniques of OIP & RIP Transformer Bushings

In this paper, Gautam Nikam and Pramod Rao of Yash Highvoltage review and describe various health monitoring and condition assessment techniques adopted by various users and recommend sequence of tests and evaluation methods.

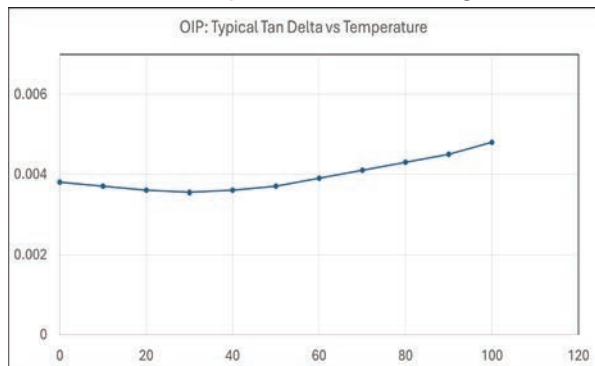
The Air to Oil type bushings are mounted on the transformer tank and oil end part is immersed in hot oil inside the transformer, and thus, based on the transformer load conditions, the bushings in service are continuously exposed to temperatures of 60 degree Celsius to 90 degree Celsius whereas the factory tests are carried out on bushings at ambient temperatures. Thus, it is important to understand and appreciate the variation of Tan Delta with reference to temperature of OIP and RIP bushings and assess its performance at test bed and during service. Typical Tan Delta vs temperature characteristics of OIP bushings is shown in the graph below. As seen, there is a variation in Tan Delta when the temperature is increasing.

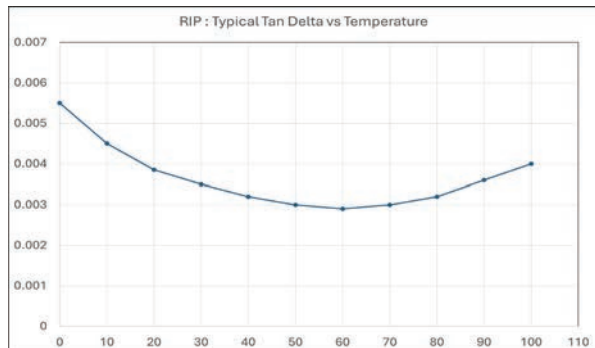
In case of RIP bushings, in view of the inherent resin material characteristics, higher Tan Delta variation (when compared with OIP) is observed with respect to temperature.

As seen from the above graph, Tan Delta varies with respect to temperature, and thus, for health or condition assessment, it is essential to convert the

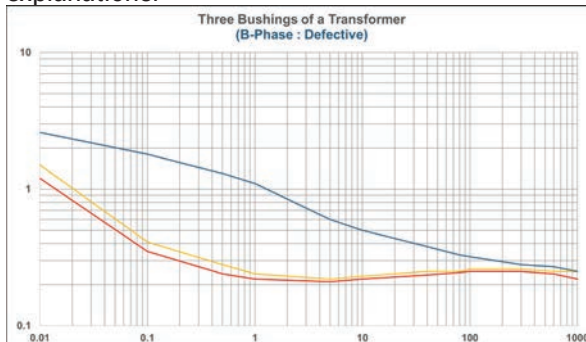
In 2022, IEEE C57.12.200 (Guide for the Dielectric Frequency Response Measurement of bushings) has been published, which explains in detail the

basics of use of DFR and case studies-based explanations.
